STILLING BASIN MODIFICATIONS BULL SHOALS DAM WHITE RIVER, ARKANSAS

Hydraulic Model Investigation

TECHNICAL REPORT NO. 2-488

November 1958

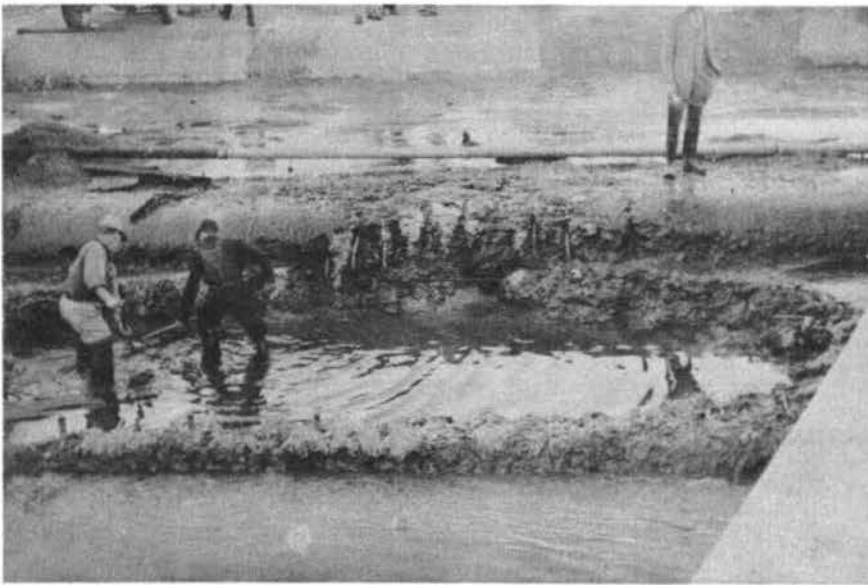
stilling basin, by use of probes and underwater viewing devices, disclosed an appreciable amount of damage to the concrete steps as well as an accumulation of assorted debris. Accordingly, it was decided that a cofferdam should be constructed downstream from the end sill so that the stilling basin could be unwatered for a thorough inspection. This inspection revealed that the floor of the basin had been damaged, to varying degrees, immediately downstream from 12 of the 16 flood-control sluices. The most severe damage had occurred just downstream from the top of the first stilling basin step. Erosion of the concrete, in some cases, reached a maximum depth of 3-1/2 ft (fig. 2). The appearance of the damaged concrete

Fig. 2. Typical damage to stilling basin steps

in certain areas indicated that initial damage had been caused by cavitation at or near the tops of the ellipsoidal steps and that, probably thereafter, a combination of cavitation and abrasive action had caused the damage to progress at an ever-increasing rate.

5. Temporary repairs were made below fourteen of the sixteen conduits by covering the first two steps with an upward-sloping concrete ramp. Downstream from one of the two remaining conduits, all four steps were covered by a sloping ramp. The steps below the remaining conduit were left as originally constructed for test purposes. During these repairs pressure cells were embedded in the concrete for determination of pressures.

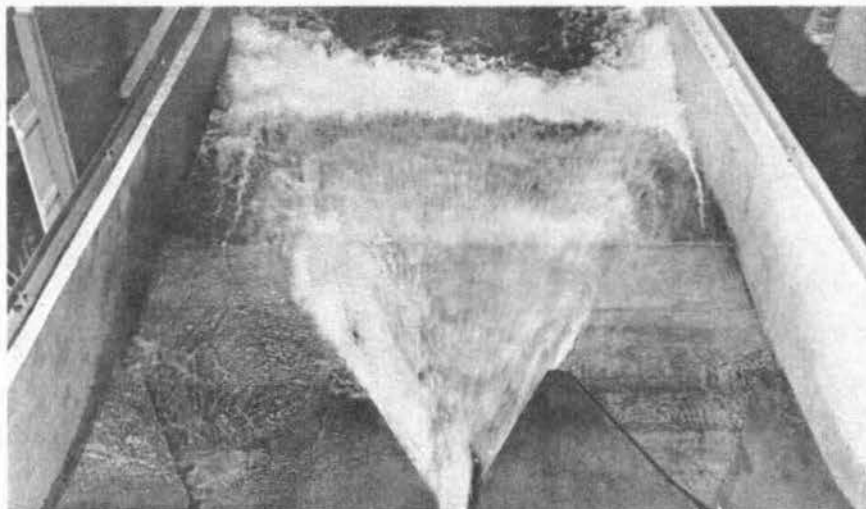
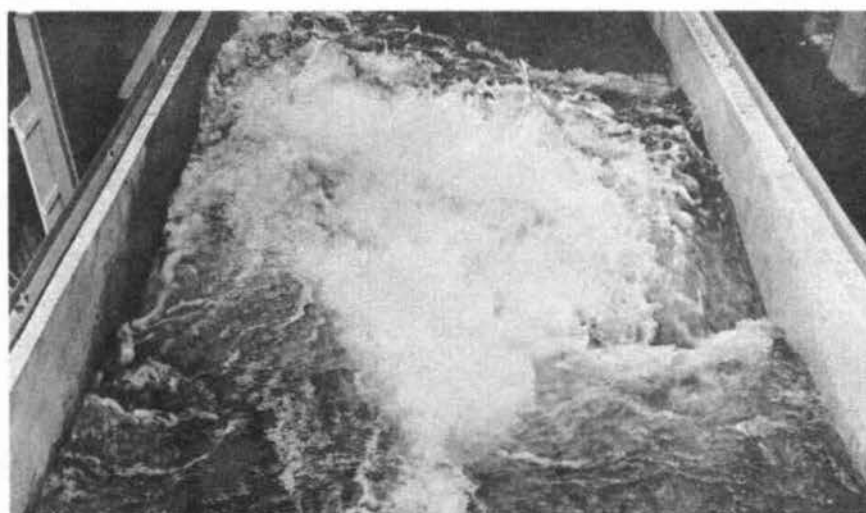
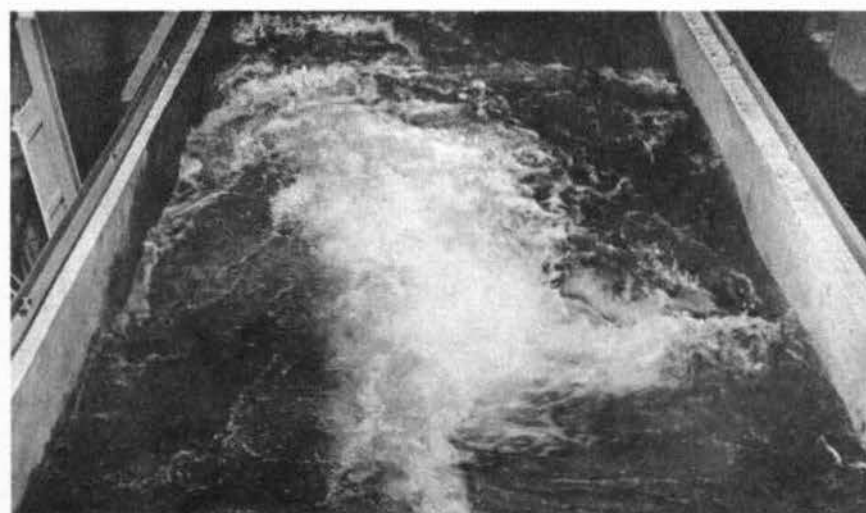
Fig. 3. The high velocity conduit jet (discharge 3500 cfs) impinged directly on 4-ft-high end sill of modification B when tailwater elevation was 452.8, but was contained in stilling basin when tailwater was between 458 and 460

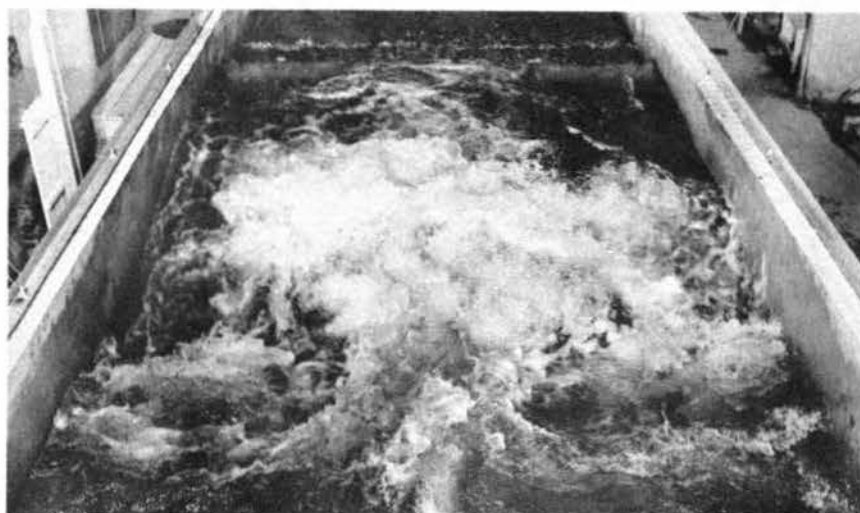
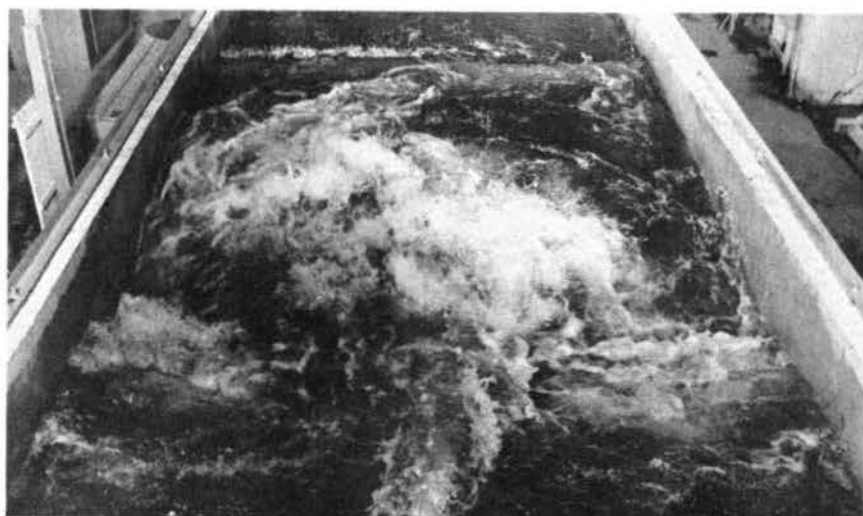
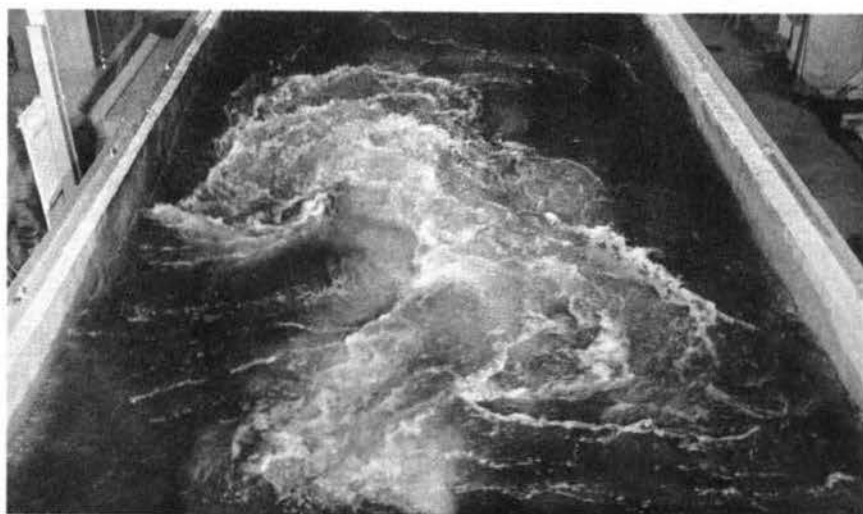
Fig. 4. Ten-foot-high end sill of modification D maintained tailwater depths capable of containing the excess energy of the conduit discharge (3500 cfs) within the stilling basin at all times

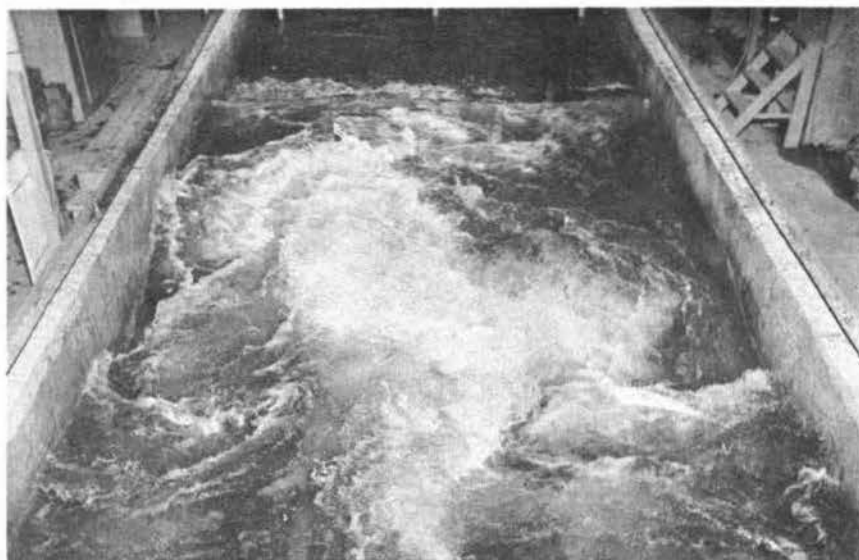
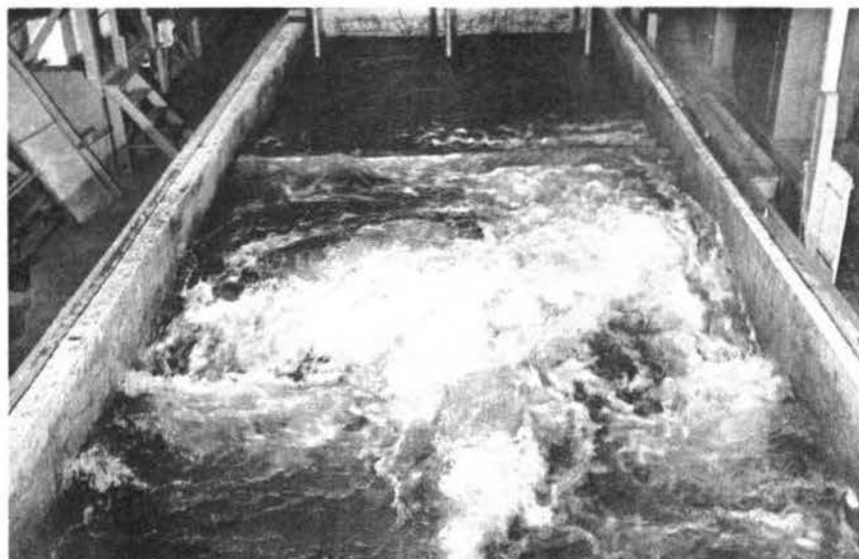
Fig. 5. High velocity jet of conduit discharge (3500 cfs) effectively confined to stilling basin by 12-ft-high end sill of modifications I and M at minimum tailwater elevation of 452.8

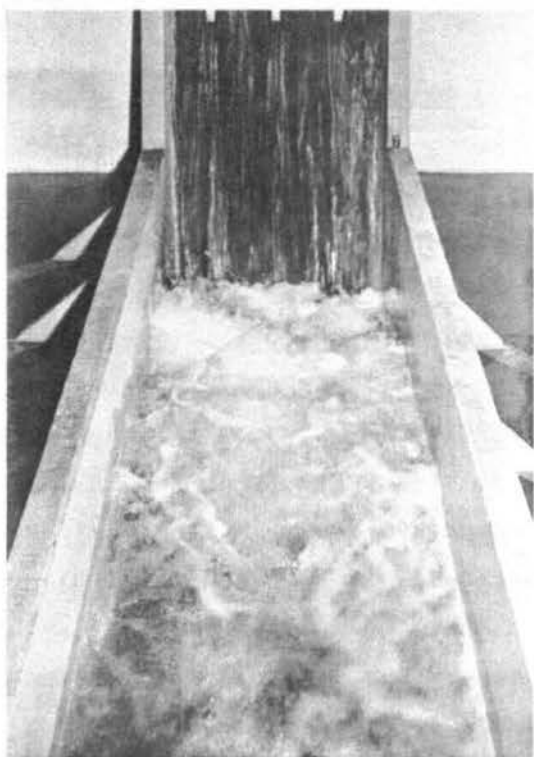
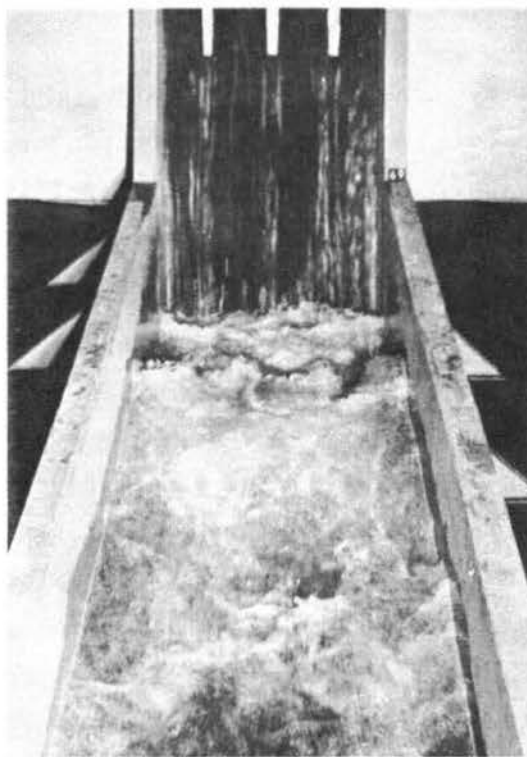
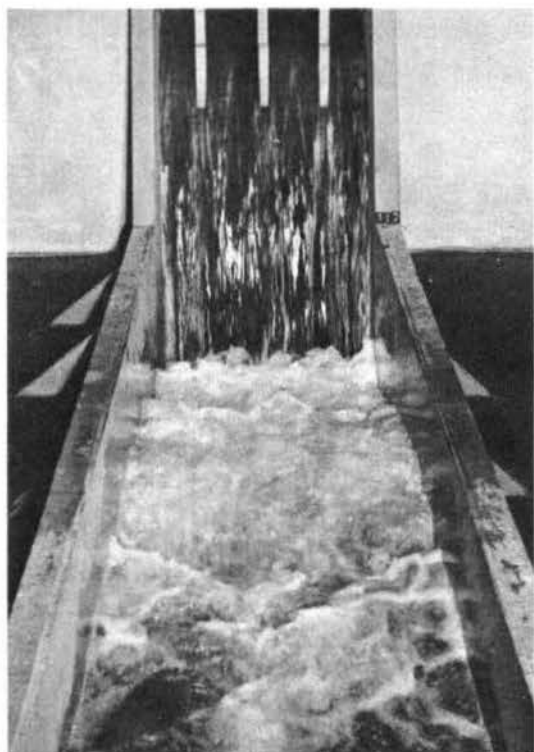
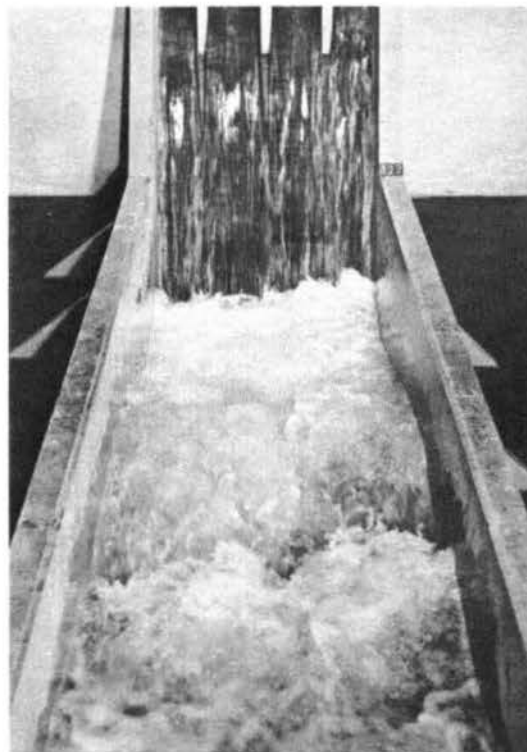
Fig. 6. Hydraulic jump formed in stilling basin of modifications B, D, M, and I at spillway design discharge of 556,000 cfs and tailwater el 514.4
